**Flood Control Project Maintenance
Levee Inspections**

Fall 2015 Levee Maintenance Deficiency Summary Report

Sacramento River Basin

| NA0008 | Overall LMA Rating | Total LMA Miles | | | | | | |
|---|---|---|---|---|---|---|---|---|
| Knights Landing Ridge Drainage District | M | 12.39 | | | | | | |

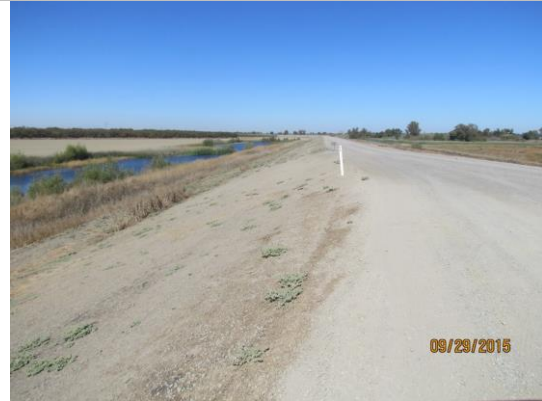
Photo 1 of 1 : FA_2015_NA0008_256_14_20151005_00013.jpg

View of the vegetation on the landward side of the levee looking upstream. Fall 2015.

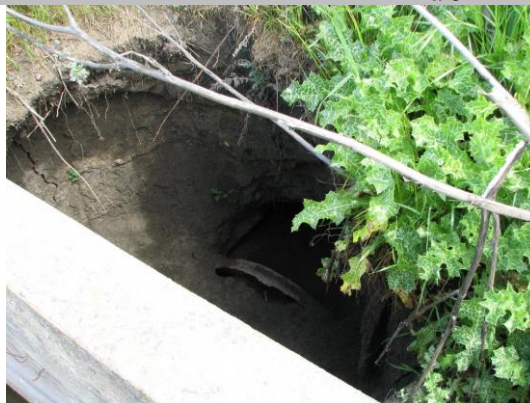
Photo 1 of 3 : UCIP_FA_2015_0269.jpg

UCIP Comments: Pipe completely rusted through on LS slope of levee at toe/headwall of concrete distribution box. Pipe needs replacement or proper abandonment. Pipe not visible at outlet.

Pipe failure at connection to concrete box on LS toe.

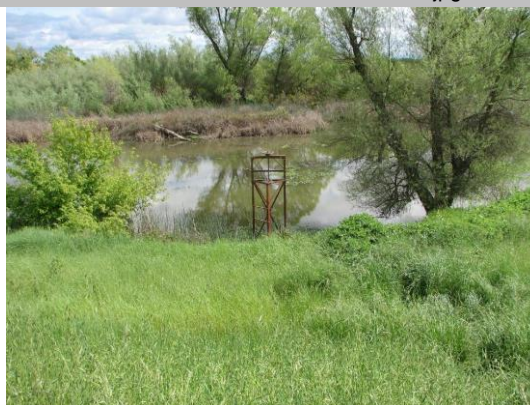
Photo 2 of 3 : UCIP_FA_2015_0270.jpg

Slide gate on metal stand on WS toe. Pipe opening not visible.

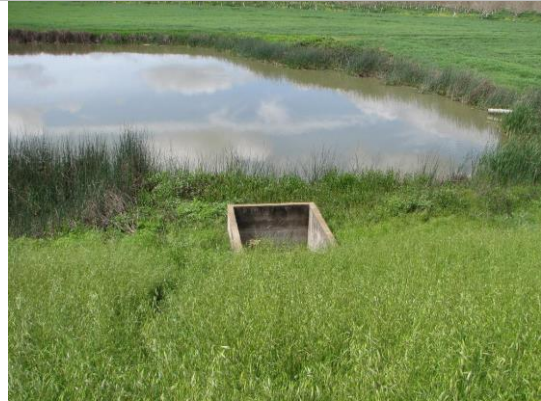
Photo 3 of 3 : UCIP_FA_2015_0271.jpg

Concrete distribution box on LS toe.

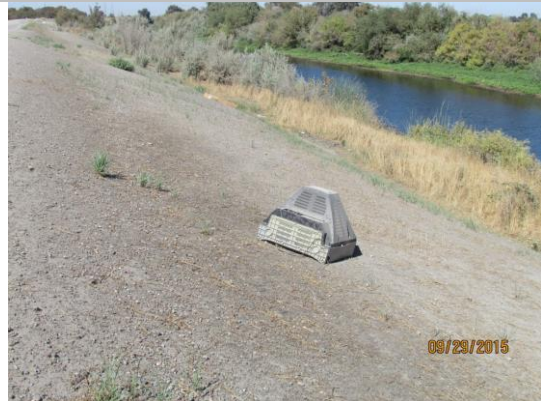
Photo 1 of 1 : FA_2015_NA0008_256_16_20151005_00014.jpg

View of the debris on the waterward side of the levee looking upstream.
Fall 2015.

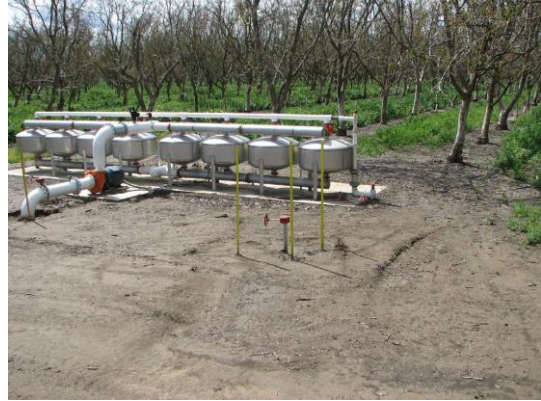
Photo 1 of 3 : UCIP_FA_2015_0423.jpg

Possible butterfly valve off LS toe.

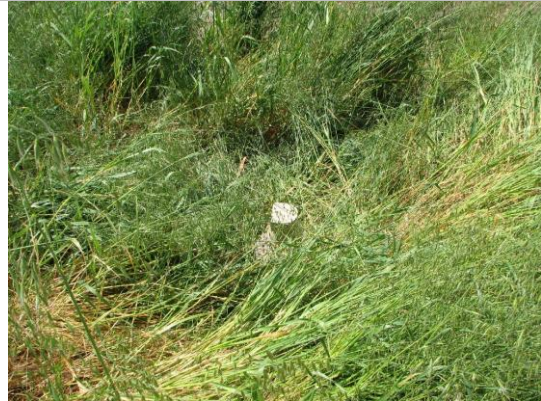
Photo 2 of 3 : UCIP_FA_2015_0424.jpg

Siphon breaker in 12-inch steel riser on LS slope.

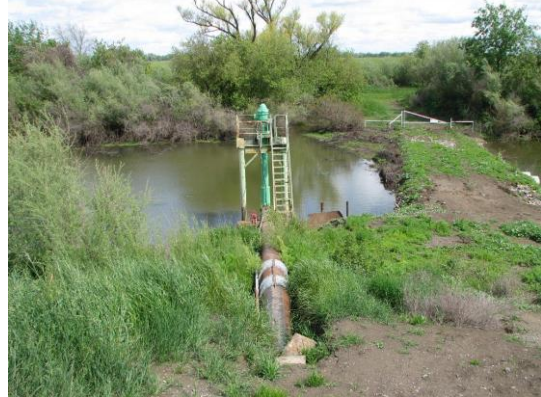
Photo 3 of 3 : UCIP_FA_2015_0425.jpg

Inspector Comments: FS_ID:11064
 DS_ID:19361
 EP_NO: 9302
 FS_HLM: 0.878
 Repair Type: Non-Urgent
 Crossing Status: Found
 UCIP Comments: Pipe exposed on WS slope in trench may need to be backfilled to prevent erosion under pipe.
 FIELD_STRUCT_DESC: 20-inch steel irrigation pipe through the levee, 8.8 feet below the crown. Pump on steel pile structure at WS toe.
 Siphon breaker in 12-inch steel riser on LS slope. Possible butterfly valve at LS toe. (Permit No. 9302-Elliott 1974), Originally included in O+M manual (1953).
 FS Date: 04/05/2013

Pump on pile at WS toe with pipe in open trench on LS slope.

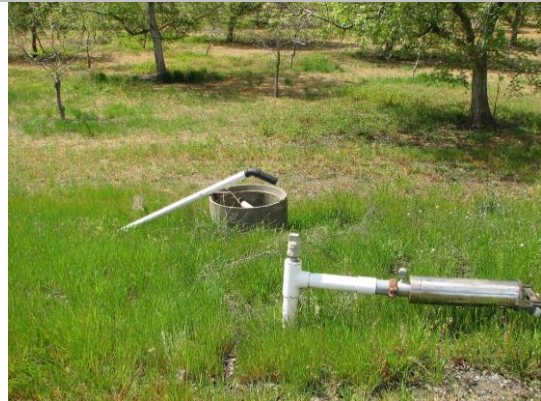
Photo 1 of 3 : UCIP_FA_2015_0426.jpg

36-inch Concrete standpipe at LS toe

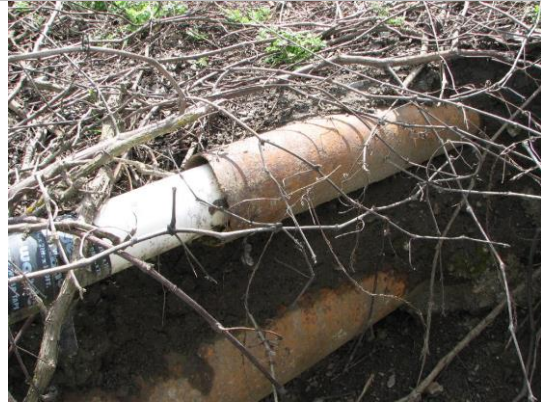
Photo 2 of 3 : UCIP_FA_2015_0427.jpg

Inspector Comments: FS_ID:11065
 DS_ID:19362
 EP_NO: 9305
 FS_HLM: 1.158
 Repair Type: Non-Urgent
 Crossing Status: Found
 UCIP Comments: Slope on WS shoulder appears to be eroding at pipes exit from levee. 36-inch conc riser on LS is filled with mud.
 FIELD_STRUCT_DESC: 10-inch pipe through the levee, 5.8-feet below the crown. Pump at the waterward toe. 36-inch Concrete standpipe at the landward toe (Permit No. 9305-Bacchini). 5-inch steel-pipe sleeved through 10-inch pipe. Annular space Grouted. (Permit No. 6076-Bacchini). Originally included in O+M manual (1953).
 FS Date: 04/05/2013

Erosion at pipes exit from levee on WS shoulder.

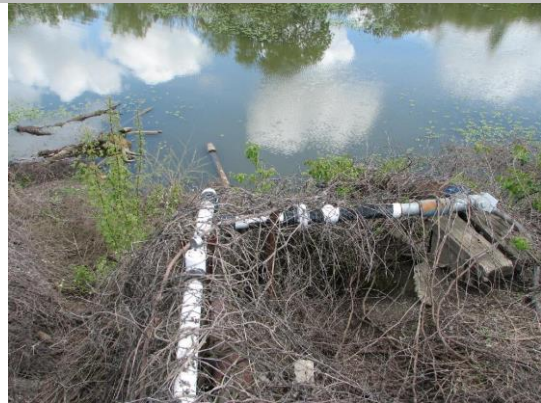
Photo 3 of 3 : UCIP_FA_2015_0428.jpg

Pump on WS shoulder overgrown and may be abandoned.

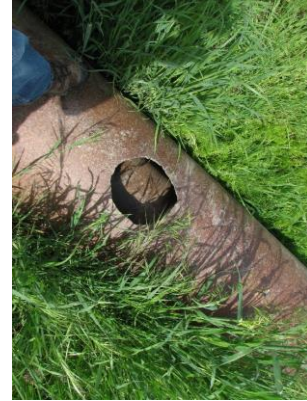
Photo 1 of 3 : UCIP_FA_2015_0272.jpg

16-inch pipe sleeved through 24-inch pipe on WS slope.

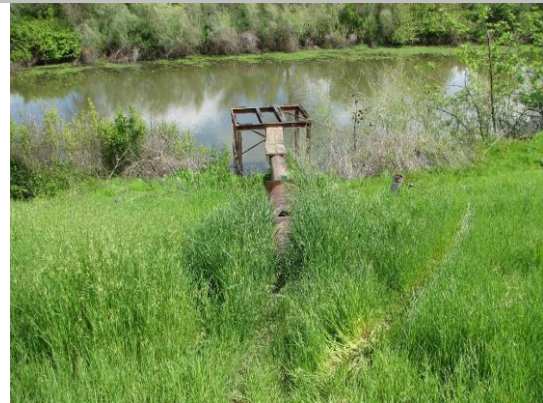
Photo 2 of 3 : UCIP_FA_2015_0273.jpg

Pipe and pier on WS toe.

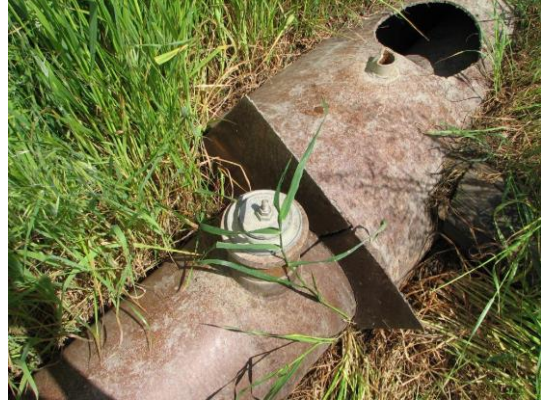
Photo 3 of 3 : UCIP_FA_2015_0274.jpg

Siphon breaker on LS slope.

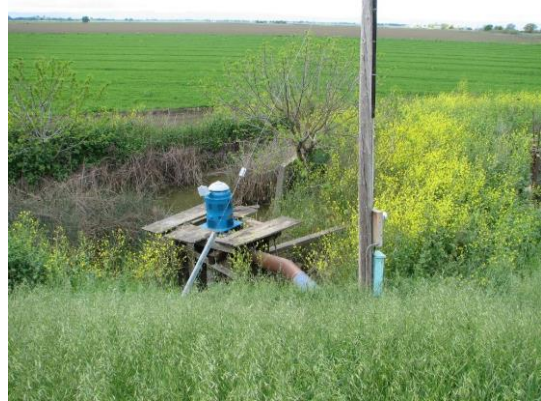
Photo 1 of 1 : UCIP_FA_2015_0445.jpg

| UCIP Comments: Siphon breaker on LS buried or broken off and missing. | | | | | |

Pump and pipe on LS toe.

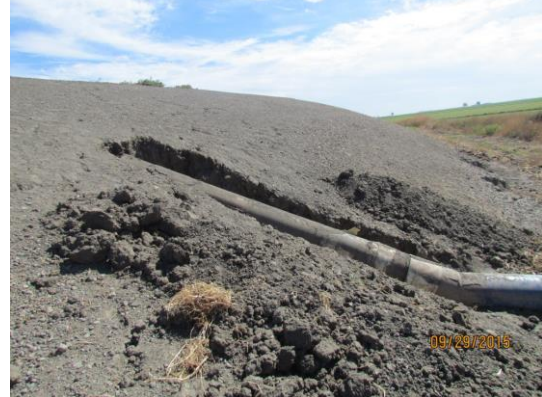
Photo 1 of 3 : FA_2015_NA0008_256_17_20151005_00015.jpg

View of the pipe on the landward side of the levee looking downstream. Fall 2015.

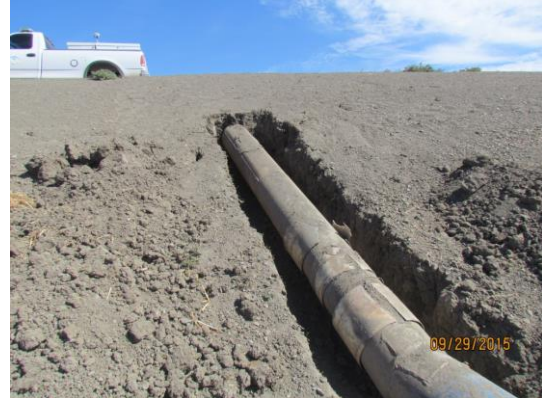
Photo 2 of 3 : FA_2015_NA0008_256_17_20151005_00016.jpg

Looking towards the crown of the levee from the landward toe. Fall 2015.

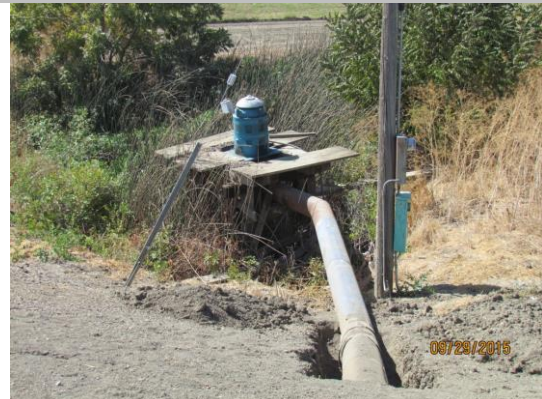
Photo 3 of 3 : FA_2015_NA0008_256_17_20151005_00017.jpg

View of the pump of the pipe at the toe of the levee on the landward side. Fall 2015.

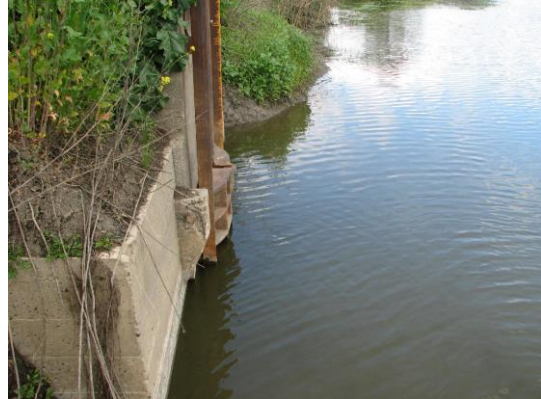
Photo 1 of 2 : UCIP_FA_2015_0275.jpg

Slide gate and concrete headwall on WS toe.

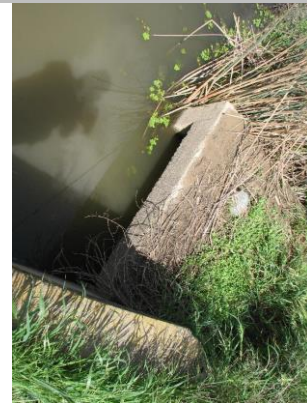
Photo 2 of 2 : UCIP_FA_2015_0276.jpg

Concrete inlet on LS toe.

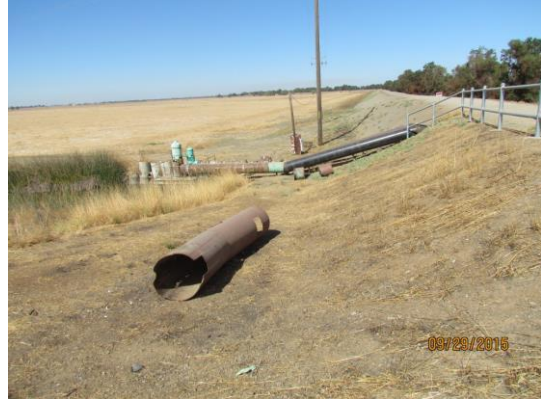
Photo 1 of 2 : FA_2015_NA0008_256_18_20151005_00018.jpg

| Inspector Comments: Portion of the pipe seems to be replaced and the abandoned pipe is left at the toe of the landward side of the levee. | | | | | |

View of the abandoned pipe at the toe of levee on the landward side.
Fall 2015.

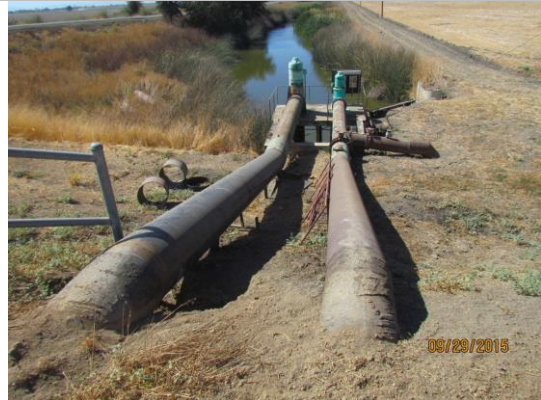
Photo 2 of 2 : FA_2015_NA0008_256_18_20151005_00019.jpg

The dark portion on the left pipe seems to have been replaced with a new pipe. Fall 2015.

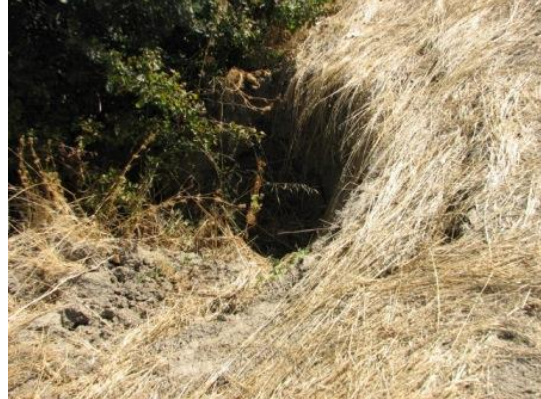
Photo 1 of 2 : FA_2015_NA0008_256_20_20150914_00005.jpg

Deep erosion at the bottom of the waterside slope 3-4 foot cut. Fall 2013

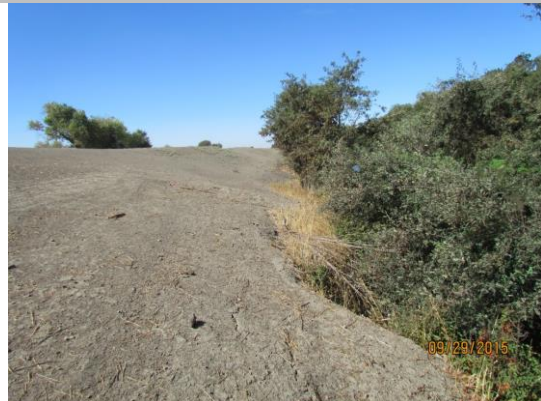
Photo 2 of 2 : FA_2015_NA0008_256_20_20151005_00020.jpg

View of the erosion on the waterward side of the levee looking upstream.
Fall 2015.

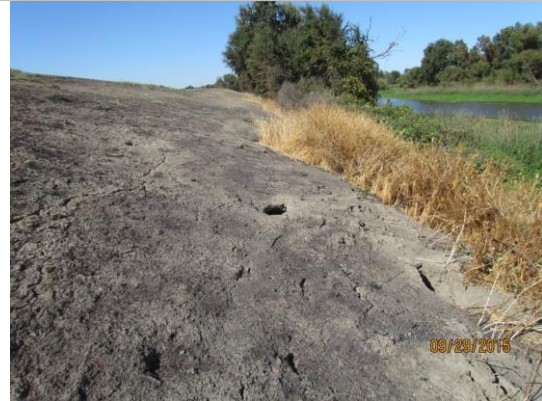
Photo 1 of 1 : FA_2015_NA0008_256_21_20151005_00021.jpg

View of the rodent holes on the waterward side of the levee looking upstream. Fall 2015.

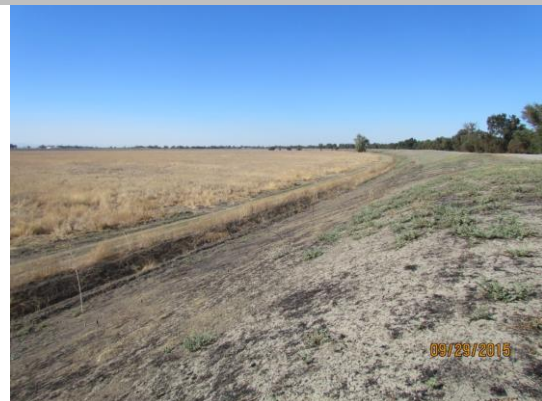
Photo 1 of 1 : FA_2015_NA0008_256_22_20151005_00022.jpg

View of the ditch on the landward side of the levee looking upstream. Fall 2015.

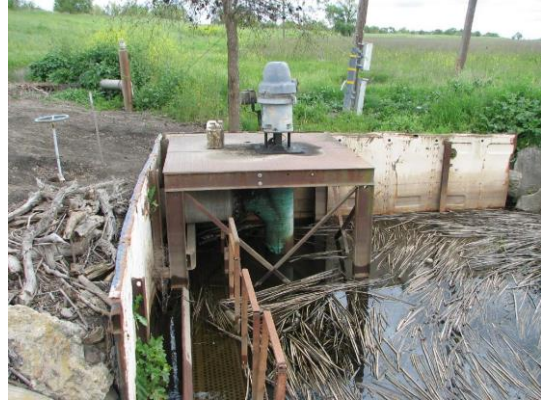
Photo 1 of 3 : UCIP_FA_2015_0195.jpg

Inspector Comments: FS_ID:11264
 DS_ID:19367
 EP_NO: 4443
 FS_HLM: 4.948
 Repair Type: Non-Urgent
 Crossing Status: Found
 UCIP Comments: Pipe does not have adequate cover at crown.
 FIELD_STRUCT_DESC: 16-inch drainage pipe through the levee 0.5-feet below the crown. Pad constructed over pipe for vehicular crossing.
 Pump on metal structure on the landward side, flap gate on the waterside end, Siphon breaker on the pipe on the waterside. Slide gate located on LS toe. (Permit No. 4443-RD 730). Design drawings available in permit.
 FS Date: 04/05/2013

Pump on Steel pile structure with slide gate at LS toe.

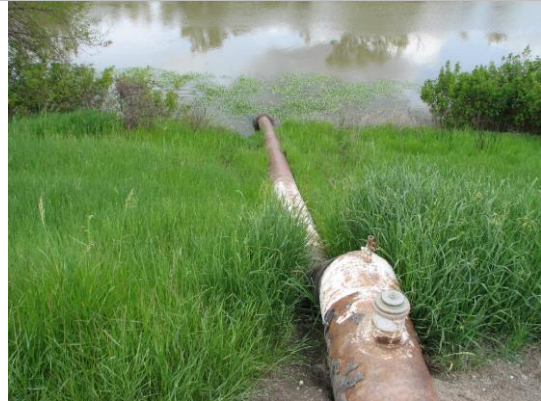
Photo 2 of 3 : UCIP_FA_2015_0196.jpg

Siphon and air vent on WS shoulder.

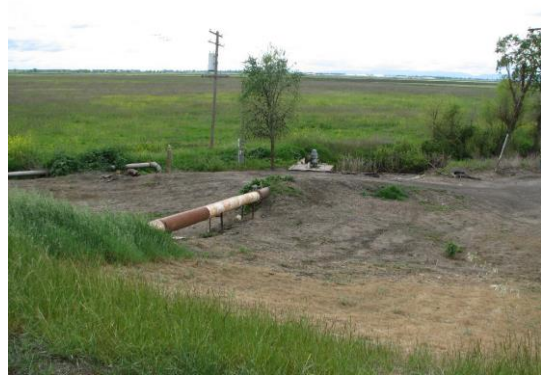
Photo 3 of 3 : UCIP_FA_2015_0197.jpg

Pump and pipe on LS toe.

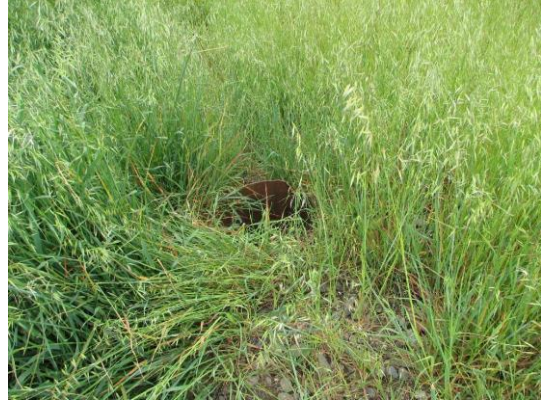
Photo 1 of 3 : UCIP_FA_2015_0198.jpg

| Action/Comments | | | | | |
|---|--|--|--|--|--|
| Inspector Comments: FS_ID:41068 DS_ID:19397 EP_NO: 5276 FS_HLM: 6.064 Repair Type: Non-Urgent Crossing Status: Found UCIP Comments: Pipe appears abandoned at this time. FIELD_STRUCT_DESC: 2 of 2: 20-inch steel irrigation pipe through the levee 4.9-feet below the crown. Vertical pump unit on pile structure in stream. Siphon breaker on the landward shoulder in 16-inch steel riser. Flap gate on the landward end. Discharges into irrigation ditch at the landward side. (Permit No. 5276-RD 730 replaced an 18-inch at this location). Steel plate welded over end of pipe at pump structure. FS Date: 04/05/2013 | | | | | |

Siphon breaker buried inside 16-inch steel riser on LS shoulder.

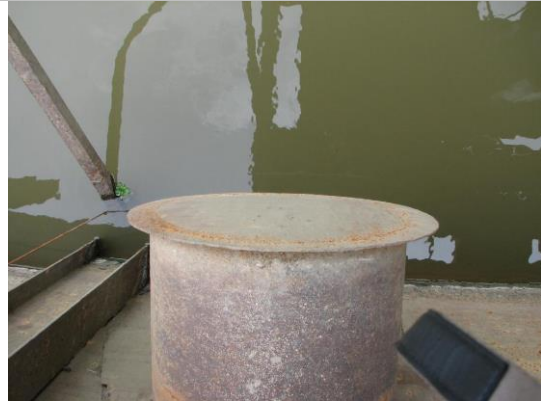
Photo 2 of 3 : UCIP_FA_2015_0199.jpg

Steel plate welded over pipe end at pump platform.

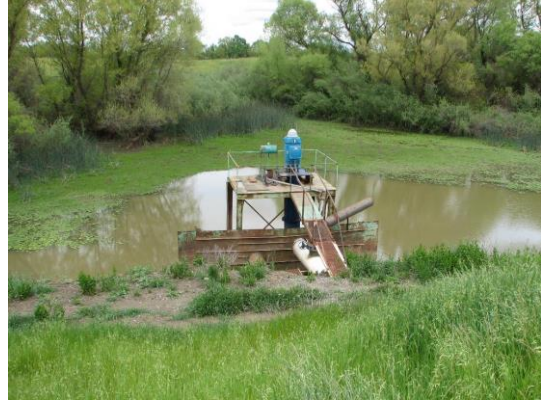
Photo 3 of 3 : UCIP_FA_2015_0200.jpg

Pump on steel structure at WS toe.

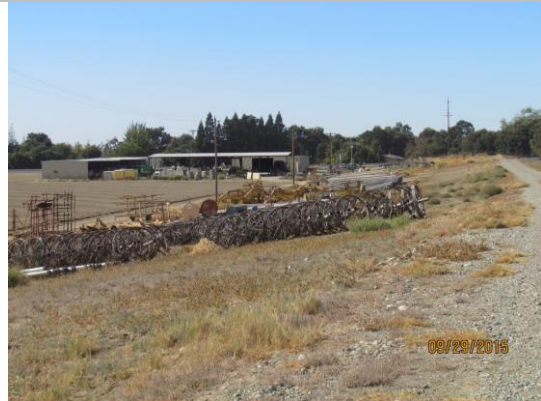
Photo 1 of 2 : FA_2015_NA0008_256_7_20151005_00023.jpg

View of the equipment on the landward side of the levee looking upstream. Fall 2015.

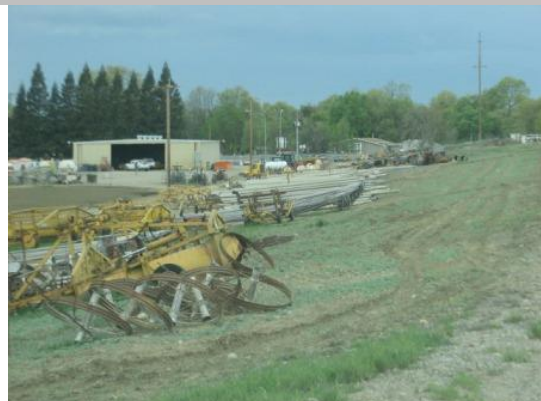
Photo 2 of 2 : FA_2015_NA0008_256_7_20150914_00002.jpg

A current view of the equipment on the levee slope. Spring 2014

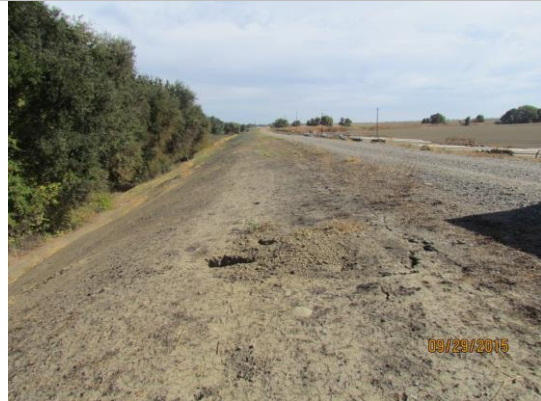
Photo 1 of 1 : FA_2015_NA0008_256_24_20151005_00024.jpg

View of the rodent holes on the waterward side of the levee looking downstream. Fall 2015.

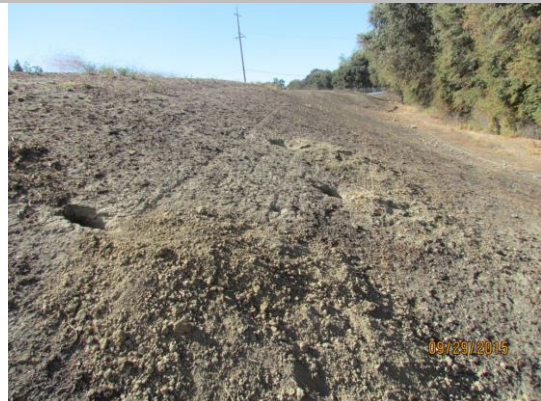
Photo 1 of 1 : FA_2015_NA0008_256_25_20151005_00025.jpg

View of the animal hole on the waterward side of the levee looking upstream. Fall 2015.

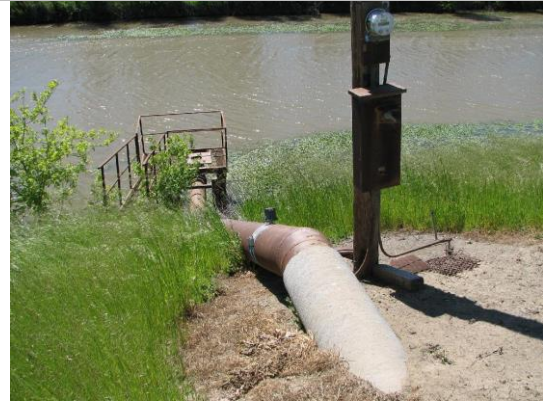
Photo 1 of 2 : UCIP_FA_2015_0218.jpg

| Inspector Comments: FS_ID:11307 DS_ID:19370 EP_NO: 9320 FS_HLM: 0.998 Repair Type: Non-Urgent Crossing Status: Found UCIP Comments: Appears abandoned as pump is missing from platform. FIELD_STRUCT_DESC: 16-inch steel pipe through the levee 2.8-feet below the crown. Discharges into 36-inch concrete standpipe at levee toe. Pump on steel pile structure in stream with metal walkway. Two service poles on the waterward slope. (Permit No. 9320-Pollock) Originally included in O+M manual 1953. FS Date: 04/09/2013 | | | | | |

Pump platform and walkway on WS toe.

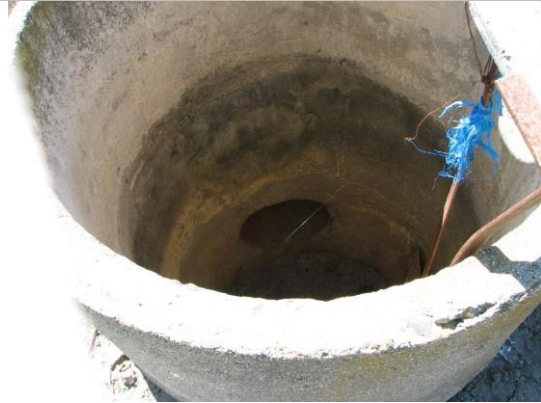
Photo 2 of 2 : UCIP_FA_2015_0219.jpg

Pipe at 36-inch Concrete standpipe on LS toe.

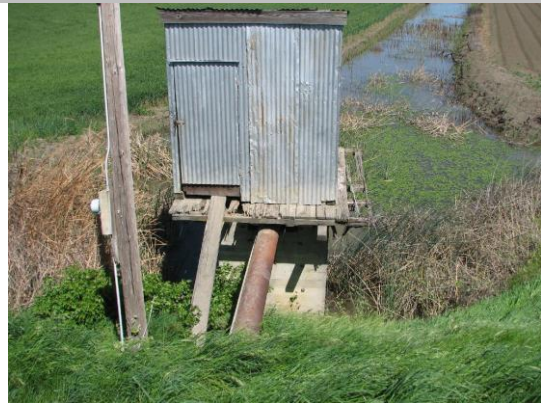
Photo 1 of 3 : UCIP_FA_2015_0215.jpg

Pumphouse on concrete platform on LS toe with JP.

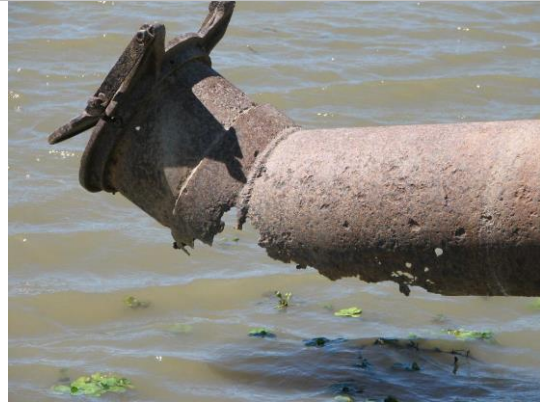
Photo 2 of 3 : UCIP_FA_2015_0216.jpg

Inspector Comments: FS_ID:11306
 DS_ID:19371
 EP_NO: 9320
 FS_HLM: 1.911
 Repair Type: Urgent
 Crossing Status: Found
 UCIP Comments: Pipe at flap gate rusted through at WS toe. Flap gate does not function properly.
 FIELD_STRUCT_DESC: 1 of 2: 12-inch pipe through the levee, 4-feet below the crown. Flap gate on waterward end at concrete headwall, siphon breaker in 2-inch CM pipe riser on the landward shoulder. Vertical pump unit on concrete foundation in irrigation ditch at the LS toe. (Permit No. 9320-Pollock) Originally included in O+M manual 1953.
 FS Date: 04/09/2013

Pipe rusted through at flap gate on WS toe.

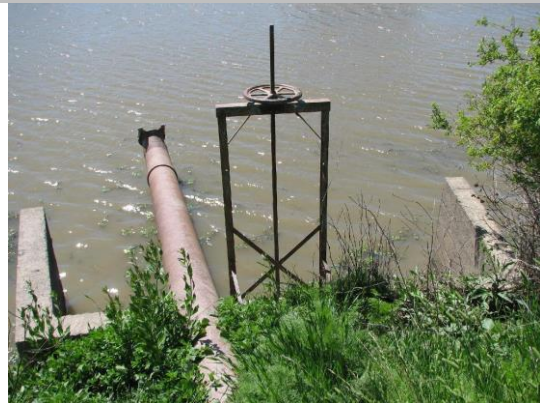
Photo 3 of 3 : UCIP_FA_2015_0217.jpg

12-inch pipe at concrete headwall on WS toe.

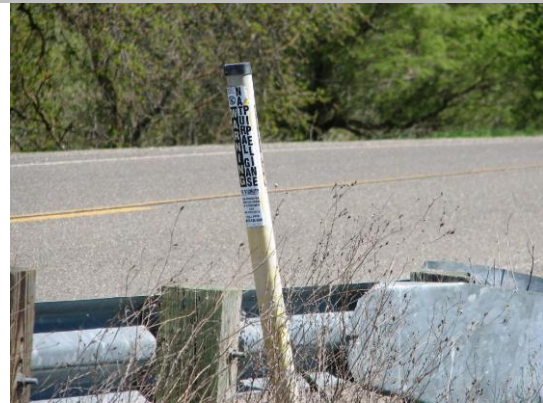
Photo 1 of 1 : UCIP_FA_2015_0214.jpg

| Inspector Comments: FS_ID:41832 DS_ID:19386 EP_NO: 13164 FS_HLM: 2.297 Repair Type: Urgent Crossing Status: Indicator Found UCIP Comments: Need to have pipe located and marked properly if still in use. FIELD_STRUCT_DESC: 4-inch steel natural gas collection pipe through the levee 3.2-feet below the crown. (Permit No. 13164, 1981). Design drawings available in permit. FS Date: 04/09/2013 | | | | | |

Sign on LS shoulder may indicate location of pipe, or it may indicate where pipe crosses approach ramp to bridge.

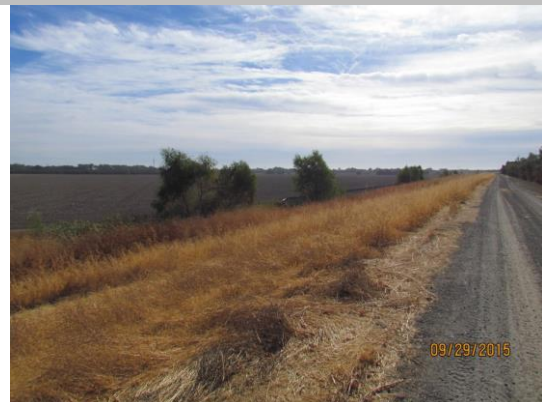
Photo 1 of 1 : FA_2015_NA0008_257_20_20151005_00023.jpg

View of the vegetation on the landward side of the levee looking downstream. Fall 2015.

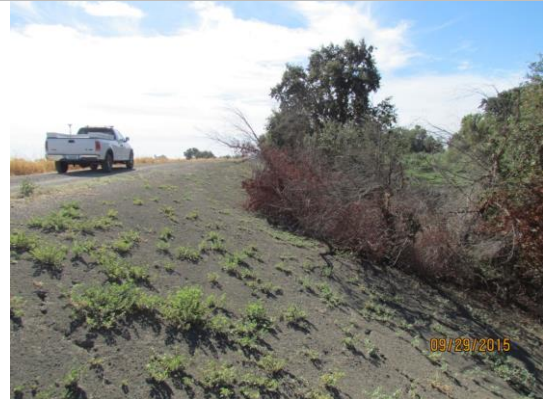
Photo 1 of 1 : FA_2015_NA0008_257_23_20151005_00027.jpg

Perspective view of the fallen tree on the waterward side of the levee looking downstream. Fall 2015.

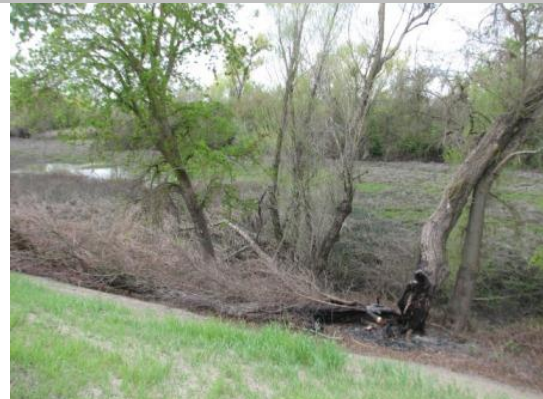
Photo 1 of 2 : FA_2015_NA0008_257_15_20150914_00004.jpg

A cottonwood tree may have been struck by lightning. The tree is split into three parts. Spring 2014

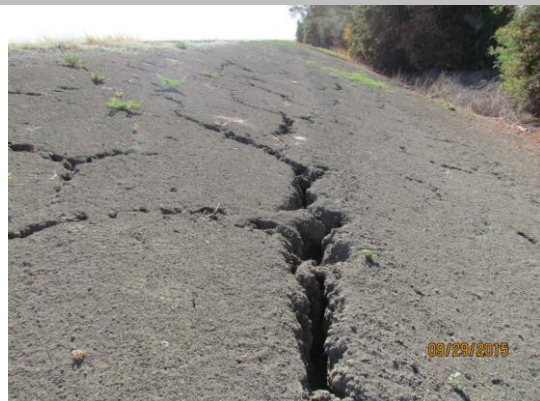
Photo 1 of 1 : FA_2015_NA0008_257_21_20151005_00024.jpg

View of the dessication crack on the waterward side of the levee looking downstream. Fall 2015.

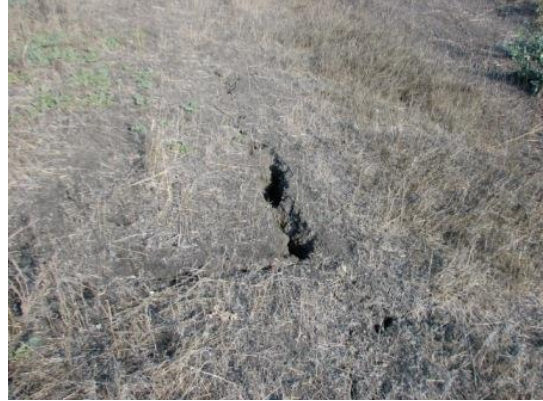
Photo 1 of 1 : FA_2015_NA0008_257_226_20150914_00005.jpg

Cracking on the landside is 3-4 inches wide and 12 inches deep. Fall 2013

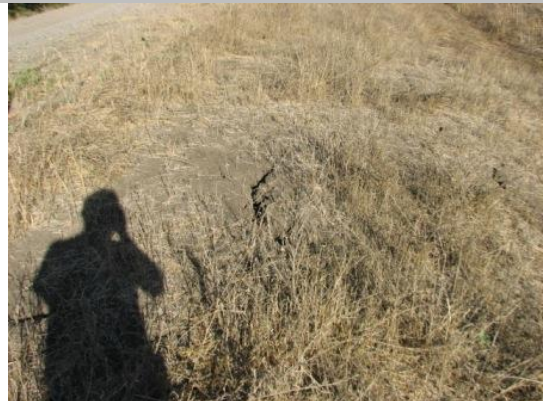
Photo 1 of 2 : FA_2015_NA0008_257_227_20150914_00006.jpg

Another view of the cracking on the levee slope. Fall 2013

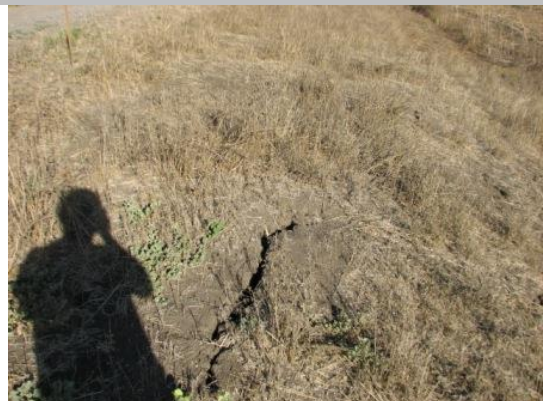
Photo 2 of 2 : FA_2015_NA0008_257_227_20150914_00007.jpg

Cracking on levee slope 1-2 inches wide and 6 inches deep. Fall 2013

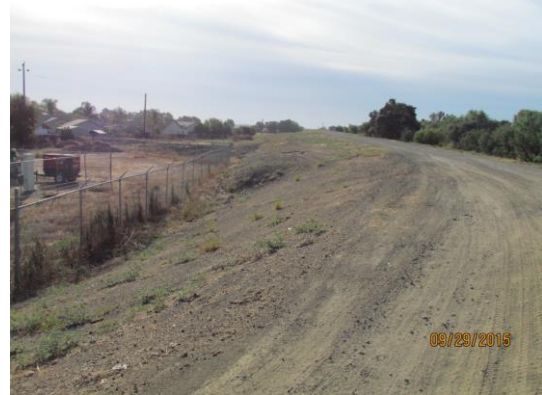
Photo 1 of 1 : FA_2015_NA0008_257_13_20151005_00015.jpg

View of the vegetation on the landward side of the levee looking downstream. Fall 2015.

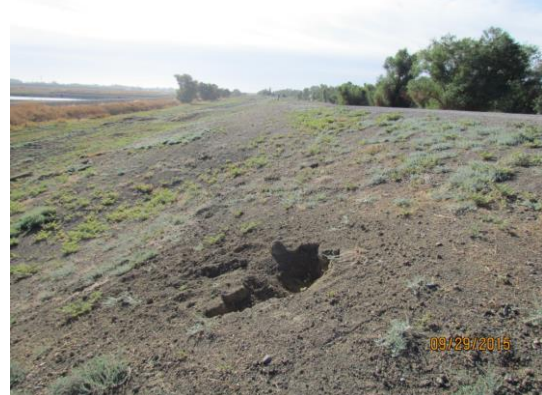
Photo 1 of 2 : FA_2015_NA0008_257_17_20151005_00016.jpg

Perspective view of the slope damaged by rodent burrows on the landward side of the levee looking downstream. Fall 2015.

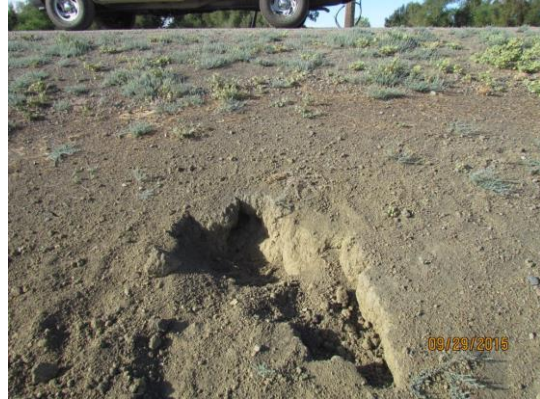
Photo 2 of 2 : FA_2015_NA0008_257_17_20151005_00017.jpg

The rodent hole does not seem to go through the levee. Fall 2015.

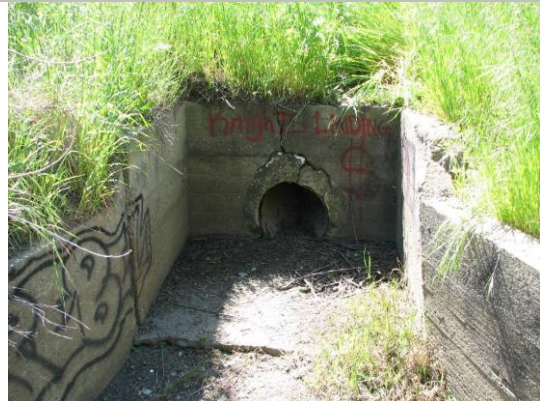
Photo 1 of 3 : UCIP_FA_2015_0211.jpg

Concrete headwall and distribution box at outlet on LS toe. Pipe heavily corroded.

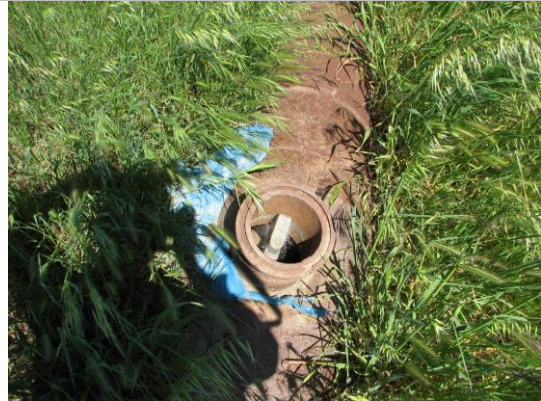
Photo 2 of 3 : UCIP_FA_2015_0212.jpg

Missing siphon breaker on LS slope.

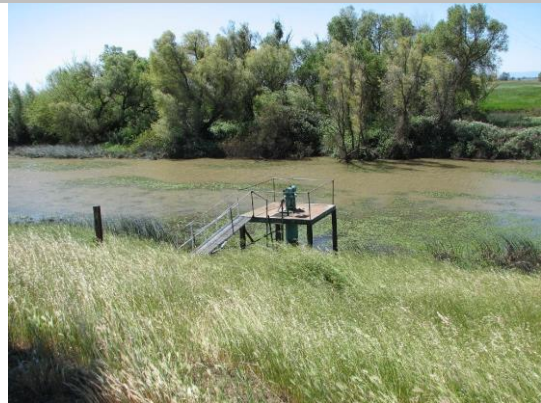
Photo 3 of 3 : UCIP_FA_2015_0213.jpg

Pump on pile structure on WS toe.

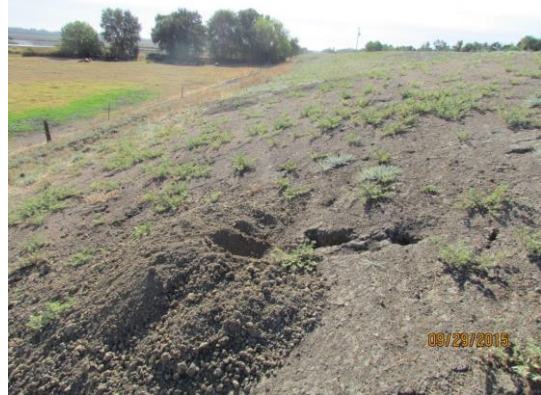
Photo 1 of 2 : FA_2015_NA0008_257_16_20151005_00021.jpg

Perspective view of the animal hole on the landward side of the levee looking downstream. Fall 2015.

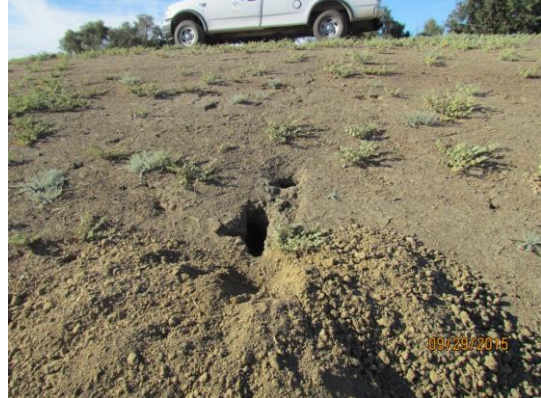
Photo 2 of 2 : FA_2015_NA0008_257_16_20151005_00022.jpg

There seems to be more than 2 cubic feet of material on the landward side of the levee. Fall 2015.

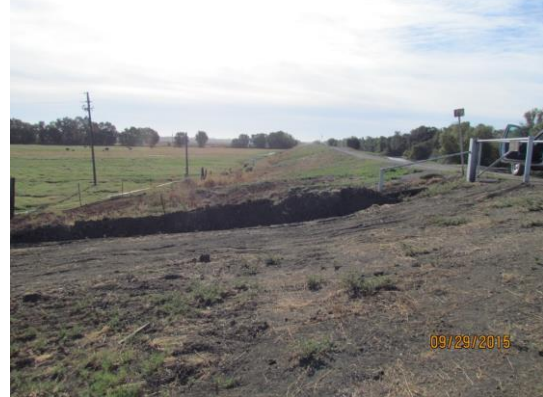
Photo 1 of 2 : FA_2015_NA0008_257_18_20151005_00018.jpg

Perspective view of the ditch on the landward slope of the levee looking downstream. Fall 2015.

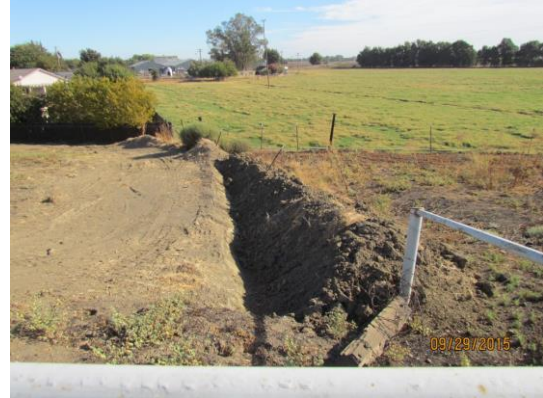
Photo 2 of 2 : FA_2015_NA0008_257_18_20151005_00020.jpg

The ditch is dug onto the landward slope of the levee. Fall 2015.

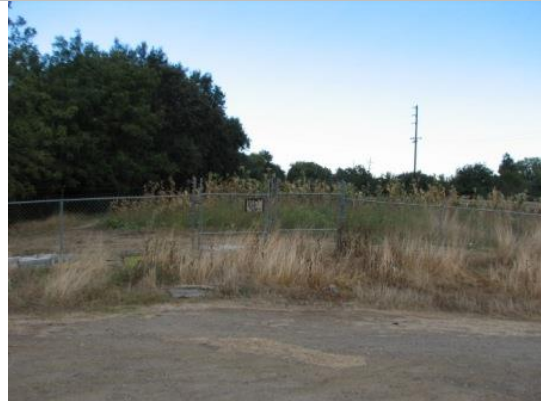
Photo 1 of 2 : FA_2015_NA0008_257_1_20150914_00001.jpg

Strawberry patch on the levee crown has added other crops on the crown. Fall 2013

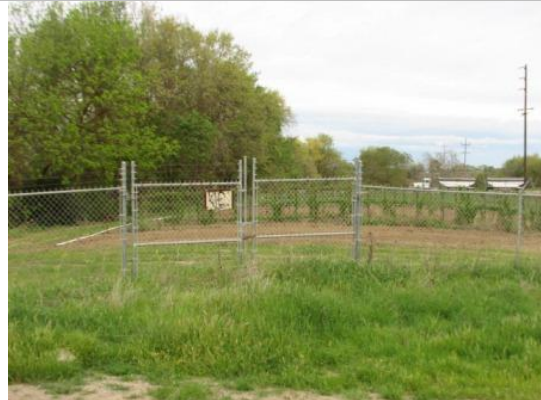
Photo 2 of 2 : FA_2015_NA0008_257_1_20150914_00002.jpg

Crops (strawberries and berry vines) are planted on the crown with a fence blocking access. Spring 2014
